RESPONSE-TO-NOISE STUDIES OF SOME AIRCRAFT AND
SPACECRAFT STRUCTURES

By Philip M. Edge, Jr., and Carl E. Rucker

NASA Langley Research Center
Langley Station, Hampton, Va.

Presented at the Second International Conference
on Acoustical Fatigue

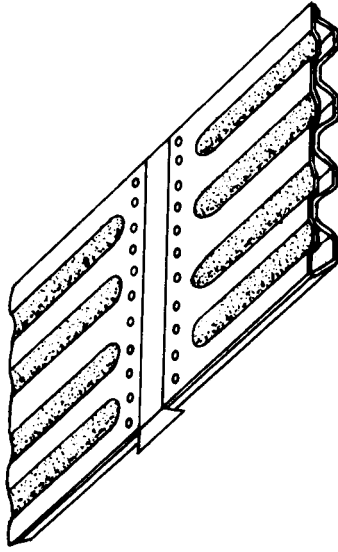
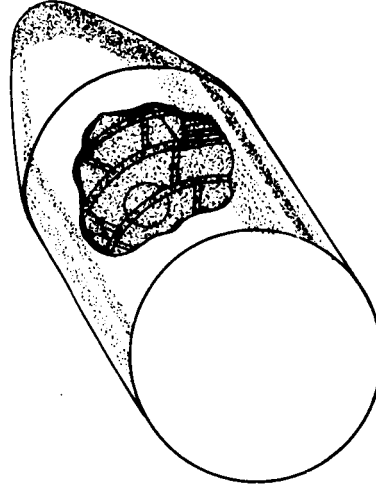
Figure 1.-- Models for structural response-to-noise studies.

The types of studies to be covered are indicated by the sketches in the first figure. The first part of the paper will deal with (panel studies, and then brief discussions will be given of studies involving shell structures and full-scale payloads. The sketch in the upper left illustrates simple aluminum panels which are being studied to determine some effects of varying the panel curvature on panel dynamic response. The sketch at the center represents a (visco-elastic panel) on which fatigue studies are being made at elevated temperatures. On the right is illustrated a corrugation-stiffened panel incorporating a thermal expansion joint. The shell structure illustrated represents a 1/5-scale Saturn I "lox" tank. The studies to be described are part of a comprehensive program to evaluate the use of models in support of structurally scaled dynamic studies of the complete Saturn vehicle. Finally, a description will be given of a full-scale environmental test on a complete Agena instrument package as represented by the sketch in the lower right of the figure. For such complex structures as these, full-scale proof testing in a realistic environment is the only satisfactory approach currently available.

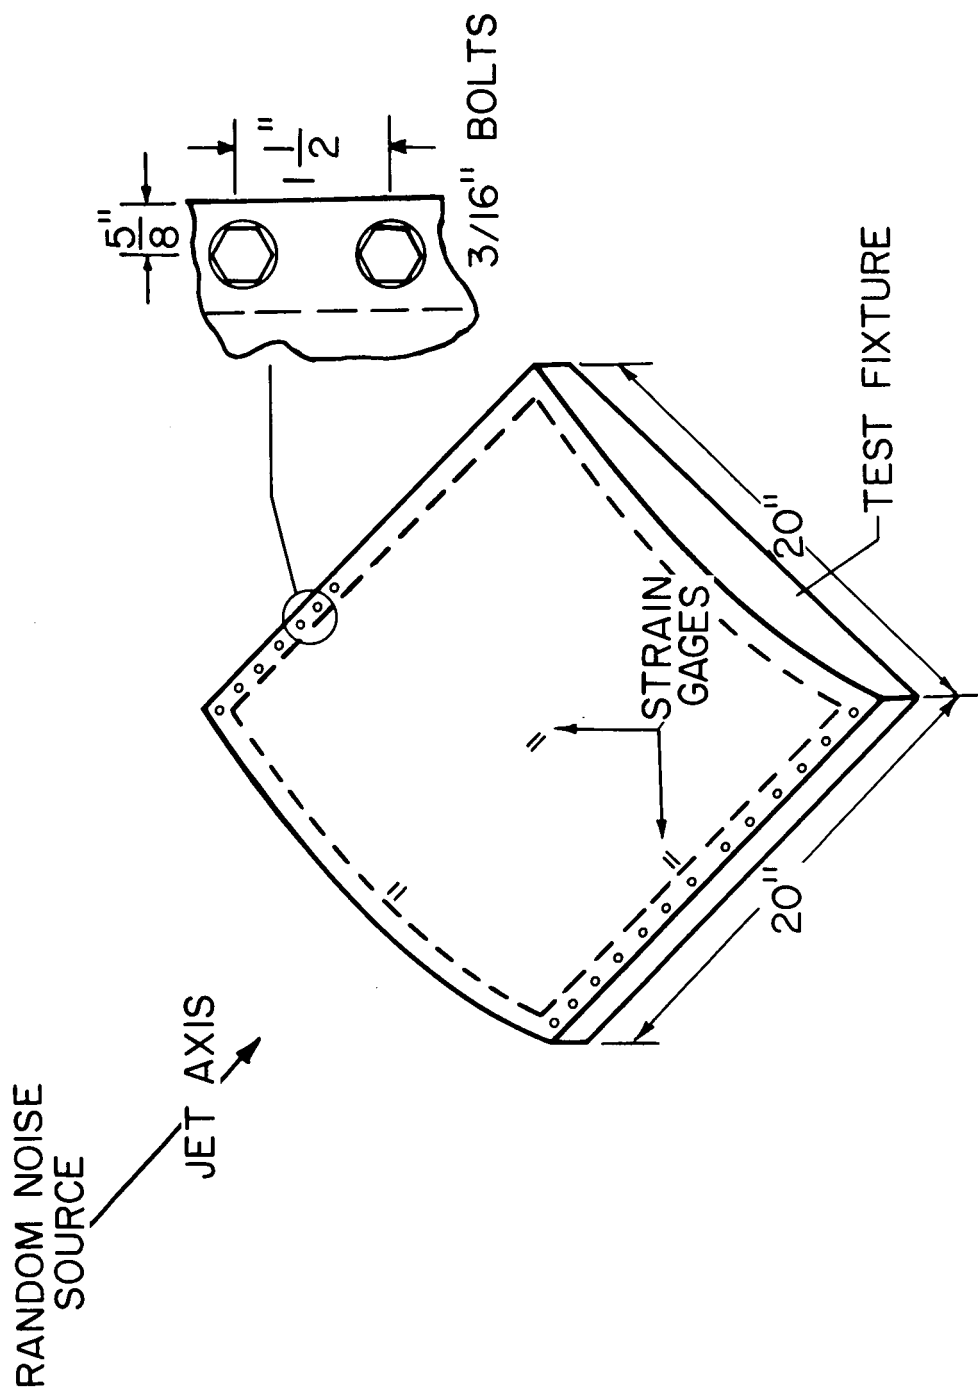
Figure 2.- Configuration for acoustic tests on 2024-T3 clad aluminum panels of 0.020-inch thickness.

Studies involving the effects of curvature were made for simple aluminum-alloy panels, as illustrated in figure 2. The panels were 20 inches by

20 inches and of 0.020-inch-thick, 2024-T3 clad aluminum. They were attached to steel test fixtures with 3/16-inch-diameter aircraft bolts with washers, and were torqued to 25 inch-pounds. Distance from the center line of the bolt hole to the panel edge was 5/8 inch, and bolt spacing was $1\frac{1}{2}$ inches. With this method of attachment, the free or effective size of the panel was approximately 17.5 inches by 17.5 inches. Panels were instrumented with strain gages and, for random noise tests, were oriented relative to the air jet noise source as indicated in the figure. Tests have been made with radii of curvature of 4 feet, 8 feet, and infinity (flat panel). Response characteristics of the panels at these curvatures were determined by means of a discrete frequency noise source which could be operated in such a manner as to sweep through a range of frequencies.

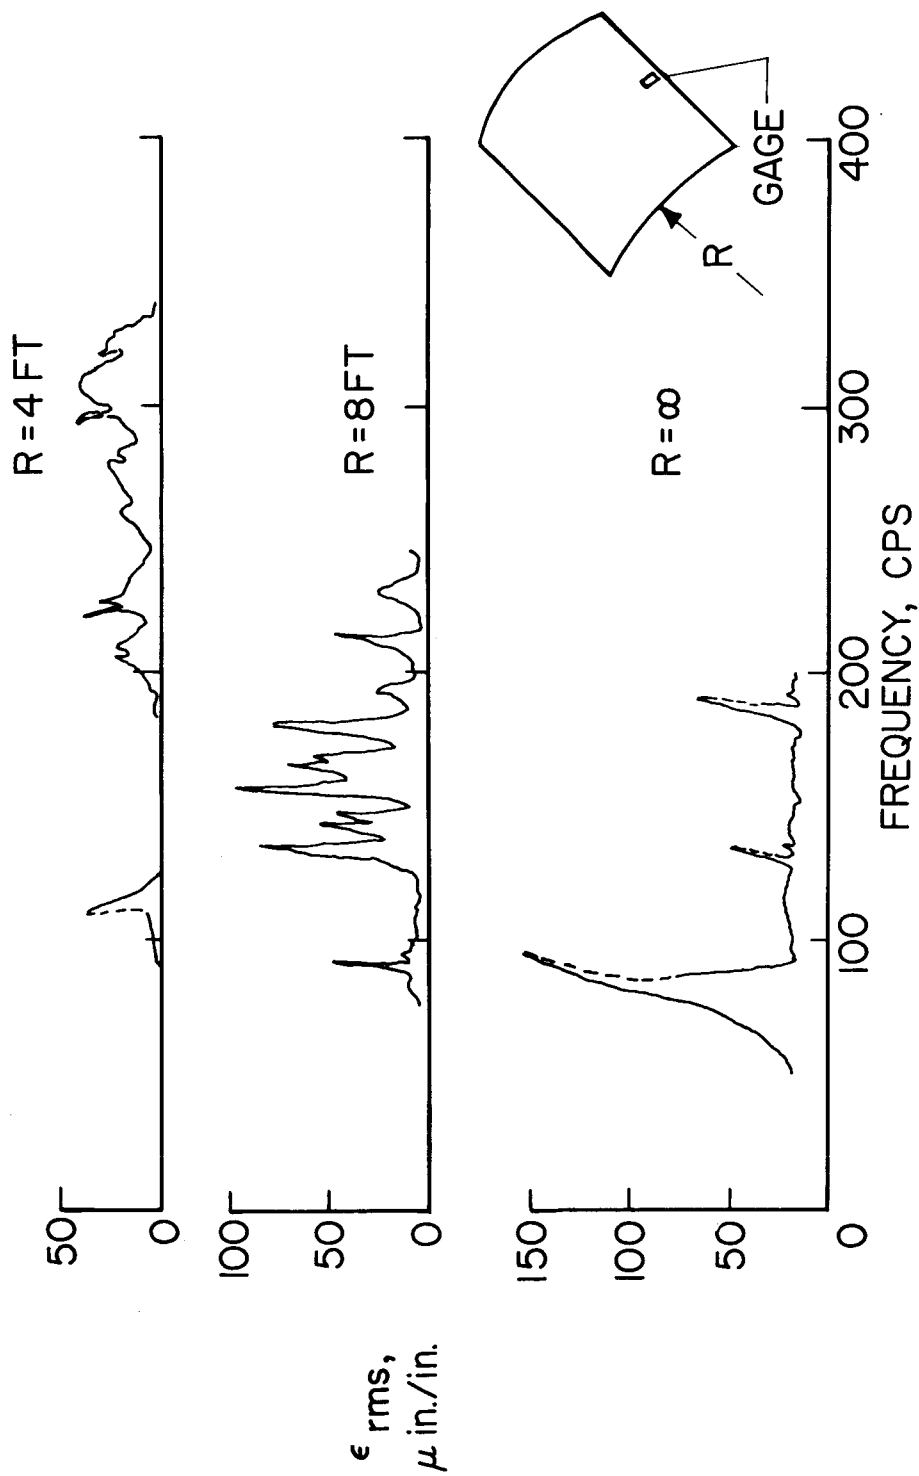
Figure 3.- Strain response as a function of frequency for 0.020-inch-thick panels of three different curvatures exposed to discrete frequency noise having a sound pressure level of 125 db.

Shown in figure 3 are the resulting root-mean-square bending strain responses plotted as a function of frequency for each of the three panel curvatures. The driving noise (normal impingement) was held at a constant 125 dB level while sweeping through the range of frequency. The characteristic flat panel response is illustrated in the bottom part of the figure. For the input noise level of the experiment, it can be seen that nonlinear effects are evident. A stiffening or hardening is seen to occur in the form of a rise in the response frequency as strain amplitude increases.

In the case of the 4-foot-radius curved panel a markedly different response pattern is obtained, as shown in the top of the figure. The strain levels are lower, there is relatively more response at the higher frequencies, and there is a trend toward a softening; that is, the response frequency tends to decrease with increasing strain amplitude. The 8-foot-radius panel exhibits response characteristics which are intermediate between those of the others and, at this particular input level, behaves essentially as a linear system.

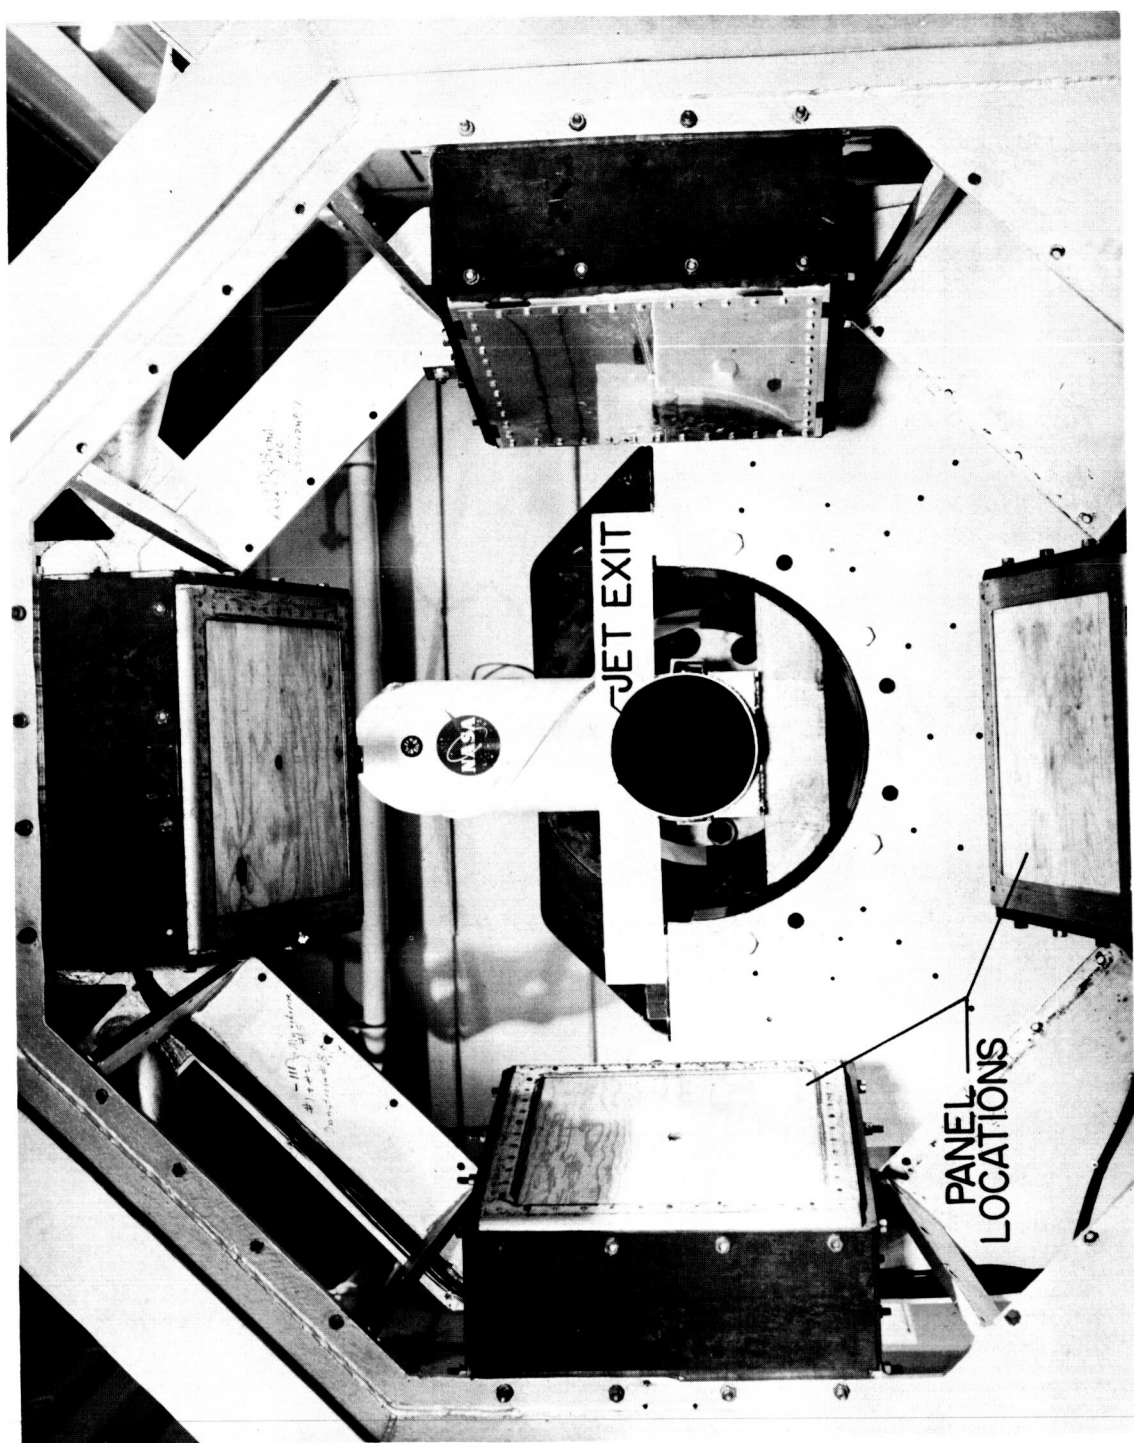
Figure 4.- Setup for random noise acoustic tests of curved panels.

Random noise tests in which a number of these panels were tested to failure were made in Langley's air jet facility, which is shown in the photograph of figure 4. The noise is the mixing noise of the air jet, and the view of the figure is looking upstream into the jet exit. Ahead of the exit are four 90° pipe bends which are useful for increasing the noise level and for shifting the noise energy in the low-frequency direction. Panel specimens are located parallel to the jet boundary in each of four positions around the jet exhaust. Overall sound pressure levels of up to 160 dB are obtained in this manner. Some of the results obtained with this setup are shown with the aid of the bar graph of figure 5, where the range of times to failure for a number of panels at each curvature are indicated. It is seen that an increase in the time to failure is associated with increased curvature. The failures obtained were skin cracks located along the edge of the washers (see fig. 2), and strain measurements were obtained near these failure locations. The curved panel strain data show a marked reduction in level compared with those for the flat panels. The fact that the curved panels did not exhibit much longer times to failure suggests that significantly different stress concentration factors may exist.

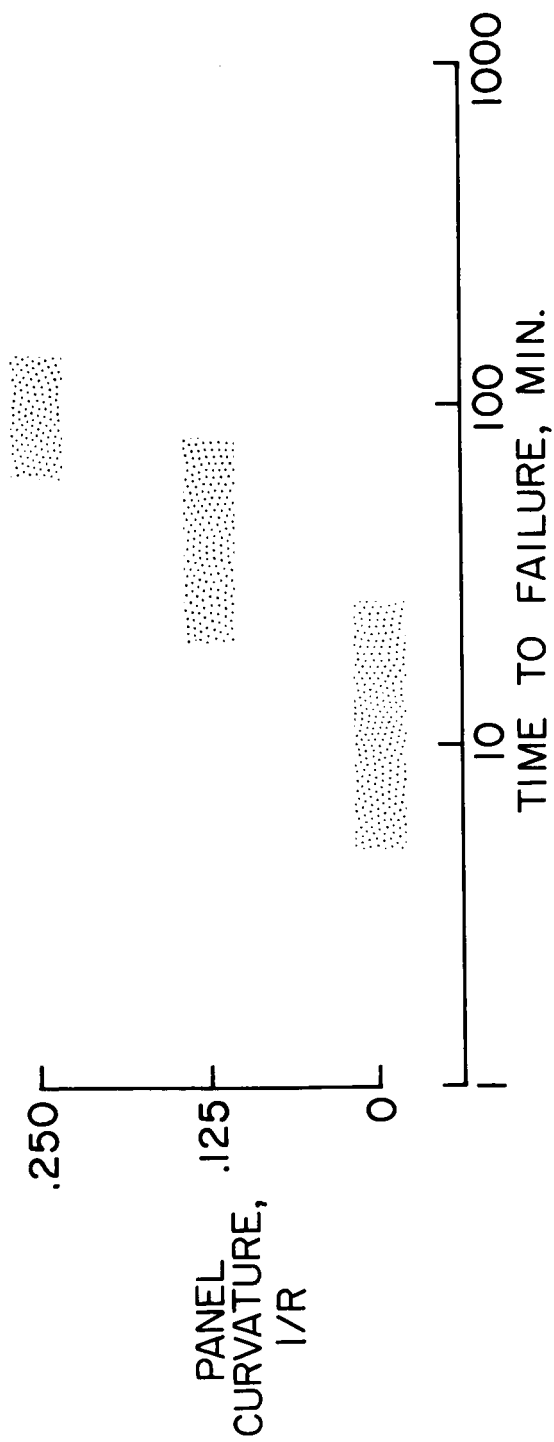
Figure 5.- Times to failure for 0.020-inch-thick panels of three different radii of curvature exposed to random noise.

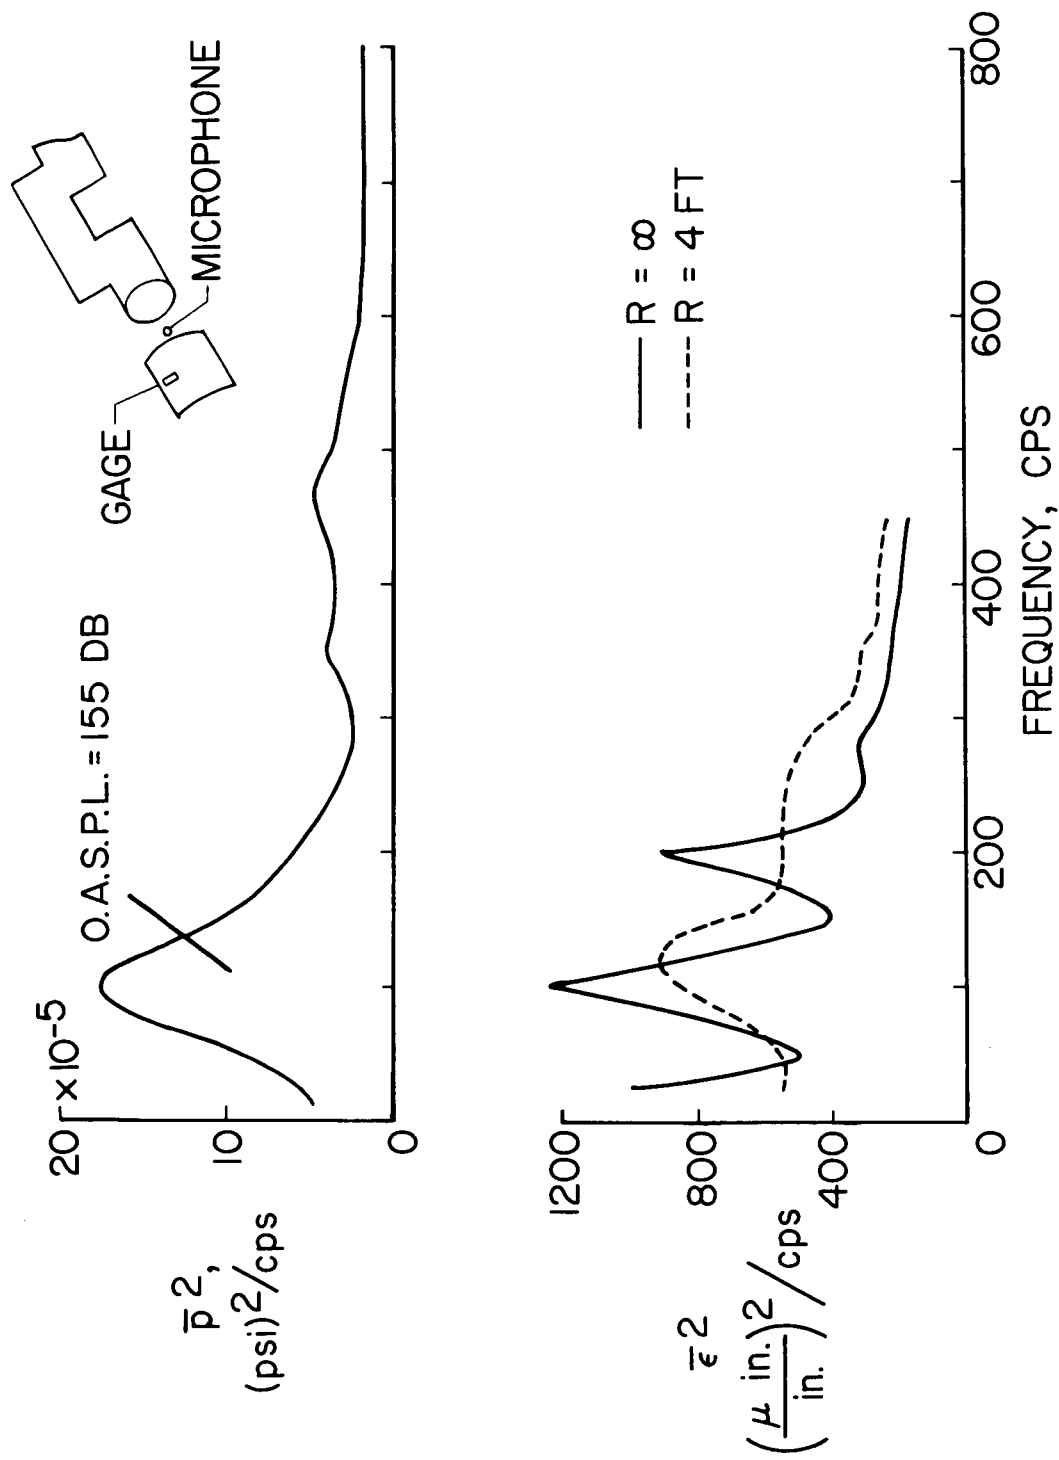
Figure 6.- Mean-square spectra of sound pressure input and strain output for aluminum panels exposed to random noise.

Figure 6 shows mean-square spectra of sound input and strain response for flat and 4-foot-radius curved panels. Sound pressure was measured at the

reference point illustrated in the figure. Mean-square sound pressures per cps (estimated from measurements using a 25-cps bandwidth filter) are plotted versus frequency in the upper graph of the figure. The above analysis shows energy of the input to be concentrated largely at 100 cps. A spectrum of strain responses (estimated from measurements using a 25-cps bandwidth filter) is shown in the lower graph in the figure. Mean-square strain in microinches per inch per cps is plotted versus frequency for a flat panel and curved panel. The curves represent the sum of the edge bending and membrane strains at the gage location shown, which is the same as for the comparable discrete frequency data of figure 3. In both cases panel response was sharply tuned near 100 cps where the input spectrum peaked; however, the panel with greater curvature has a greater response at the higher frequencies. The flat panel (solid line) bending strain peaked at 100 cps, and the membrane strain peaked at twice the bending frequency. For the 4-foot radius of curvature panel the membrane response was low and lacked prominent peaks; thus the response spectrum of figure 6 is essentially the bending strain responses. A prominent peak is still shown between 100 and 125 cps.

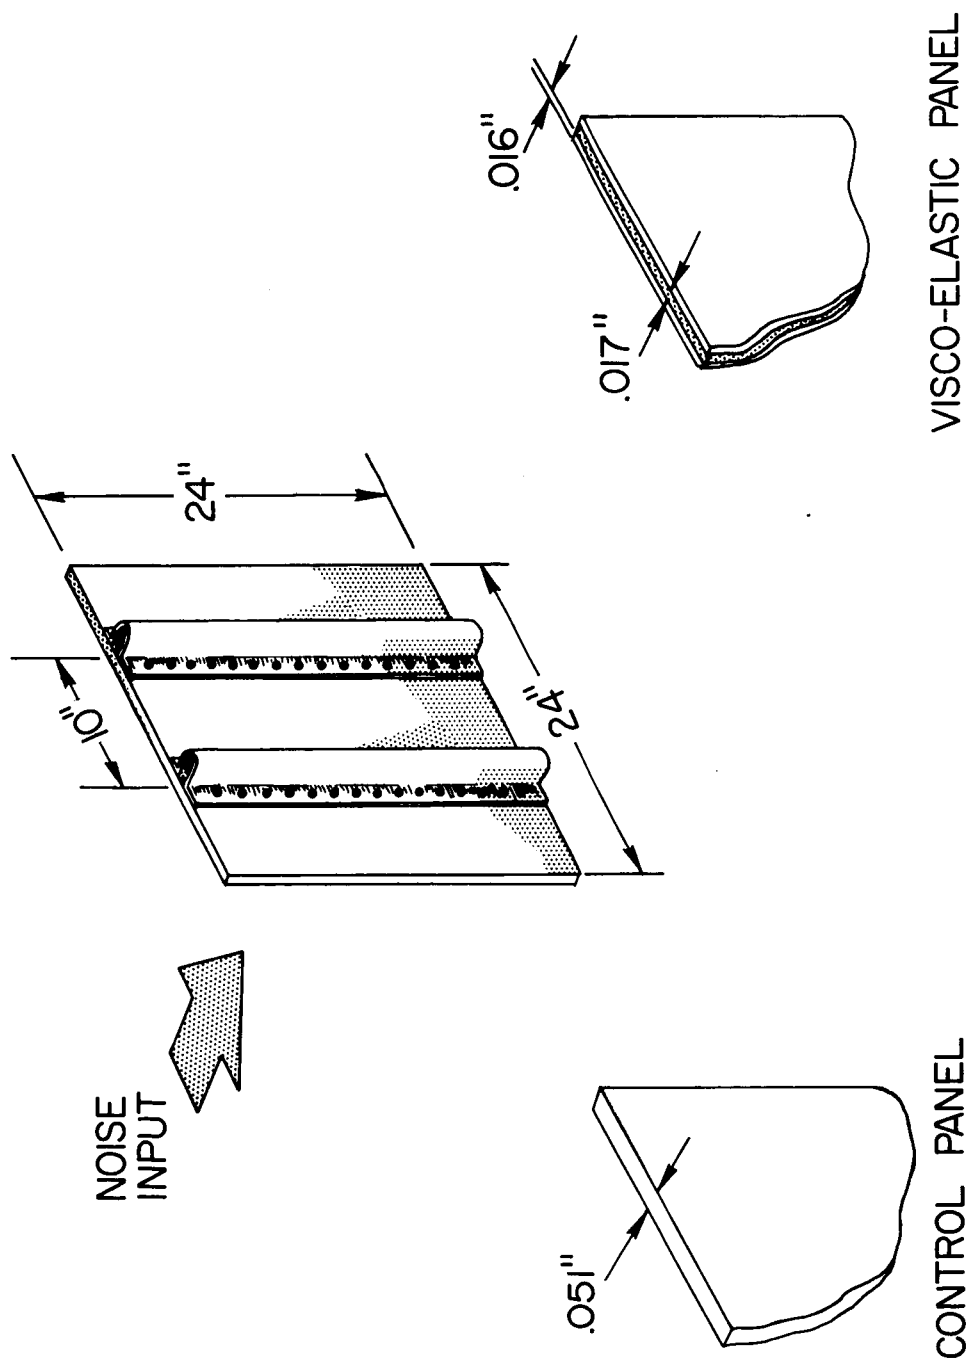
Figure 7.- Visco-elastic panel test configurations.

Studies to determine some effects of combined elevated-temperature—intense-noise environments on fatigue of commercially available visco-elastic panels are underway under a contract with North American Aviation of Columbus, Ohio. Configurations for which some data have been obtained are illustrated schematically in figure 7. The panels are 24 inches square with two hat-shaped stringers riveted across the back side. These stringers were located 5 inches from the center line, thereby forming a 10-inch by 24-inch panel bay in the center. The visco-elastic panels were made up of two aluminum facing sheets of 0.016-inch thickness with a 0.017-inch thickness of visco-elastic material (trade name - Dyna-Damp) bonded between the sheets as illustrated. A control panel of 0.051-inch-thick aluminum was constructed and tested for use as a reference for comparing the results obtained with the visco-elastic panels. All aluminum used in these tests was 2024-T3 clad. The edges of the test panels were riveted to $1\frac{1}{2}$ -inch channel frames which in turn were attached to the mounting frame of the acoustic test chamber. The tests were made in the grazing incidence test chamber of North American's discrete frequency siren facility. In the wall of this chamber the panels were mounted with the stiffeners running vertically on the panel surface away from the noise (fig. 7). In the opposite wall of the test chamber was a series of quartz tube heat lamps for heating the panels. The testing technique used was to sweep through a frequency range in the operation of the siren at the sound pressure level of the test. From this frequency sweep the fundamental resonant frequency of the panel center bay was determined from strain-gage measurements, and the tests were run at this frequency. Three control panel specimens and three visco-elastic panel specimens were tested at sound pressure levels of 148, 154, and 160 dB, both at room temperature and at 200° F.

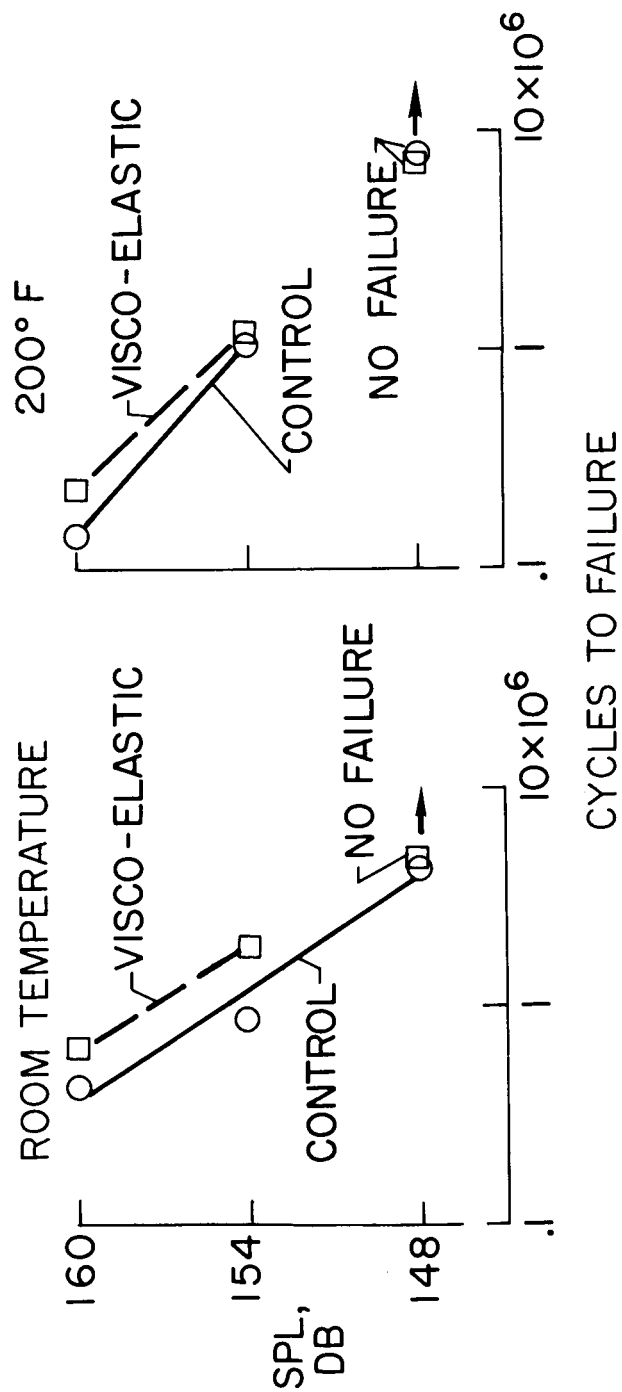
Figure 8.- Cycles to acoustic failure for visco-elastic and simple aluminum control panels at room and elevated temperature.

Some results from these tests are shown in figure 8. Shown in this figure are the cycles to failure as a function of noise level in decibels. Failure was

judged to have occurred when skin cracks were first visible. These cracks generally were detected near the rivet attachments of the center bay of the test specimens. The plot on the left shows results obtained at room temperature, and the plot on the right shows the results obtained at 200° F. The data points shown are the average of the data obtained on the three panels tested under each condition. These data show that the visco-elastic panels generally endure a larger number of cycles before failure is detected. This margin of improvement is greater for the room-temperature conditions than for the 200° F conditions. This result suggests that the visco-elastic material may be losing some of its effectiveness at the elevated temperature condition.

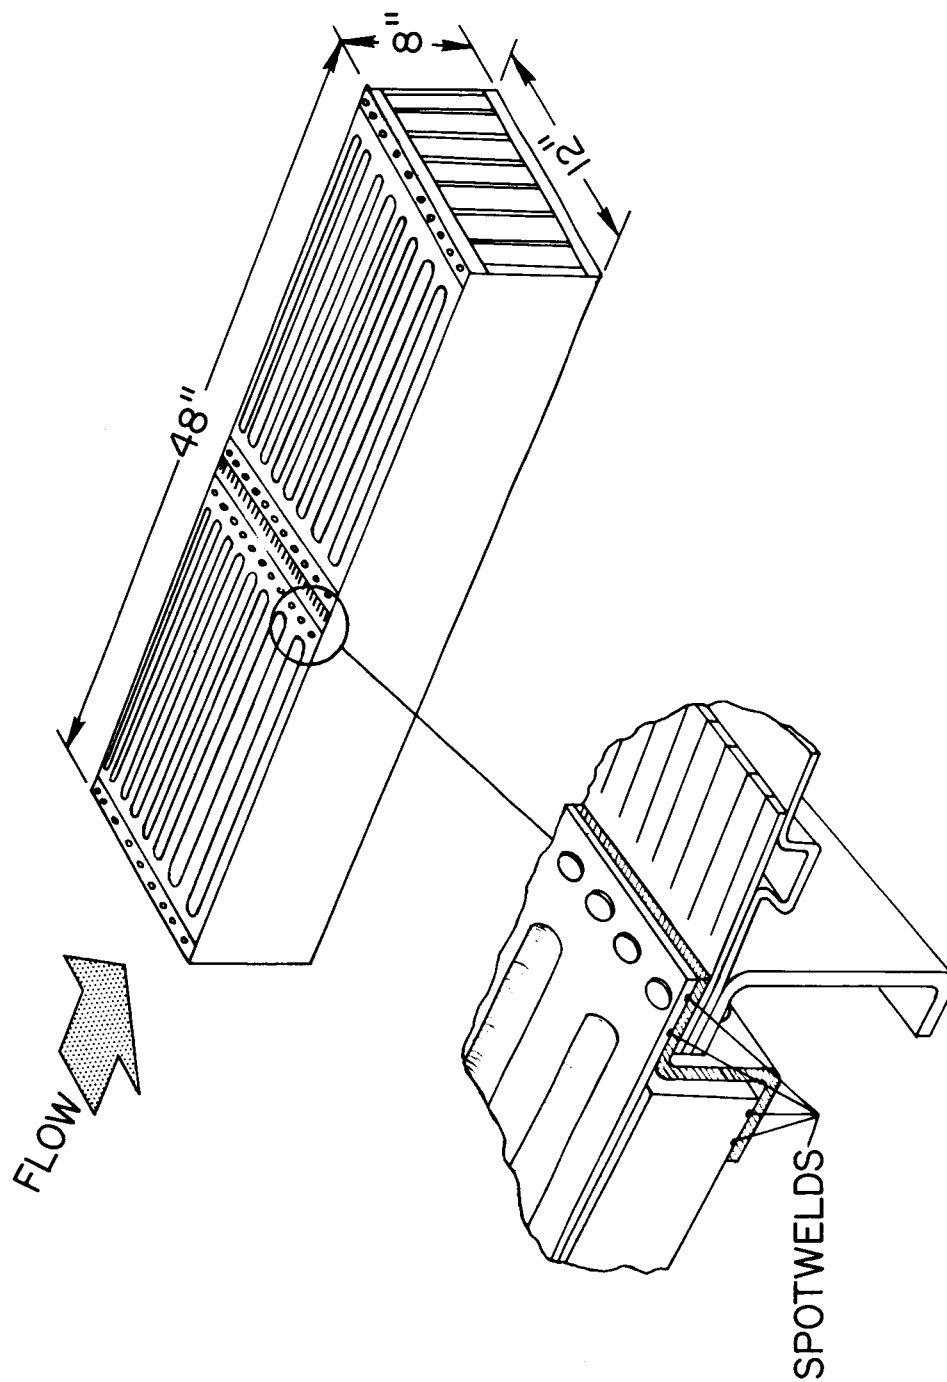
ENLARGED VIEW OF FASTENING

Figure 9.- Test configuration of corrugated skin panel.

The structure studied is illustrated in figure 9. As shown, the test panel structure is 12 inches wide by 48 inches long and forms the top surface of an 8-inch-deep box. The part of the structure which was studied in detail was an expansion joint which is illustrated by the inserted sketch. The material used was light-gage Inconel X, fabricated by a welding-riveting process. The top skin was bonded and stiffened by a corrugated under skin, welded to form a composite panel. Of special interest in these acoustic tests are the panel skin terminations at the expansion joint. The outer skin was terminated by a row of rivets at the expansion joint attachment. The inner skin was terminated by a Z-member which was spot welded to each of the corrugation flats. These spot welds were found to fail during acoustic fatigue tests, and outer skin surface cracks developed along the attachment rivet line. The effects of noise level and edge attachment detail on the growth of the outer skin crack are indicated in figure 10.

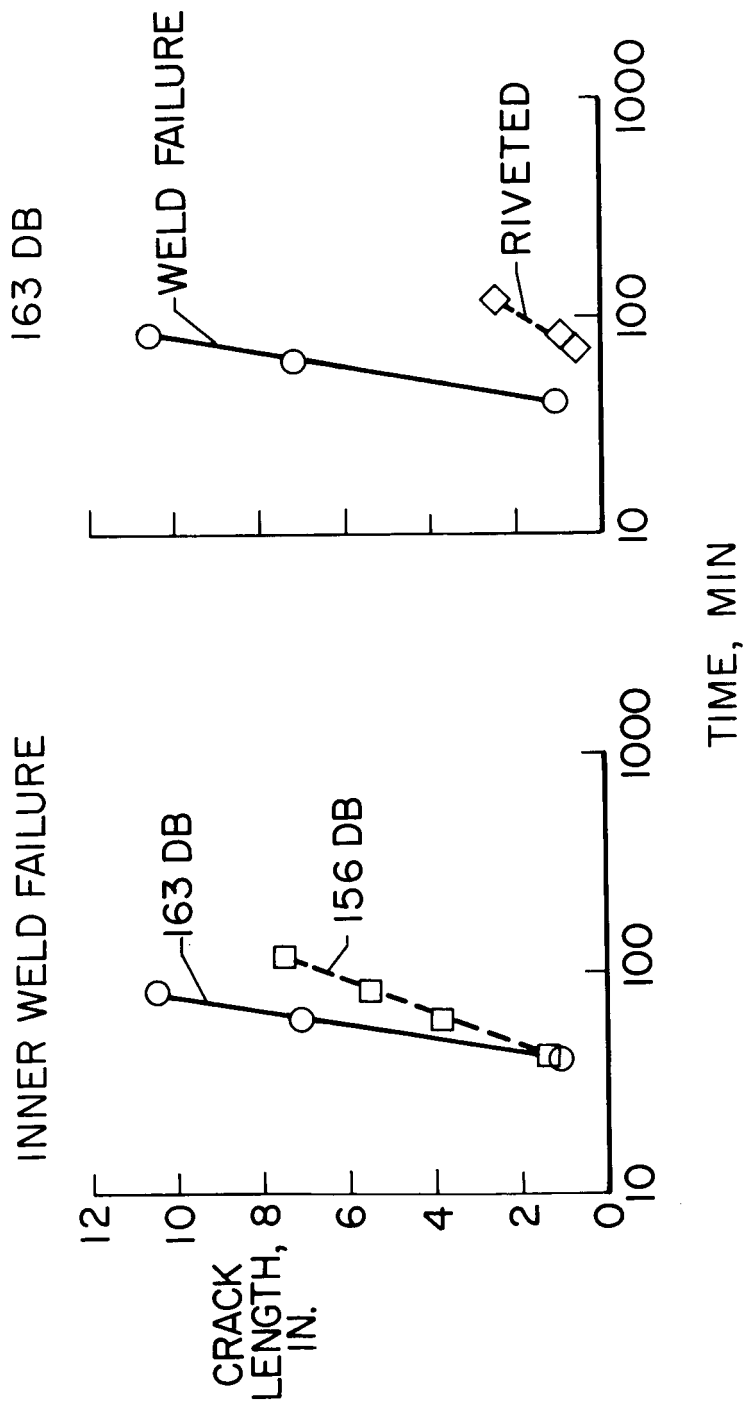
Figure 10.- Crack length as a function of time for two noise levels of excitation and for two configurations of panel internal attachment detail.

Shown in this figure are plots of crack length as a function of time in minutes. Data on the left are for sound pressure levels of 163 dB and 156 dB, and for the condition of an initial failure of the undersurface welds. It can be seen that the crack growth is markedly faster for the higher noise level condition. The experiment was repeated for the condition of a riveted instead of a welded Z-attachment of the internal structure in the region of initial failure. As a result of using rivets in this internal structure, the time to failure of the outer skin and the associated rate of crack growth were markedly reduced, as can be seen in the right-hand figure. A point to be made from these data is that the structural integrity of interior attachment points of this type of built-up panel construction can be very important in the time to failure of skin surfaces and also in the crack growth problem. It should also be mentioned that, although skin surfaces may be readily inspected, the inaccessible under-structures may be an important inspection problem relating to the fatigue of the skin surfaces.

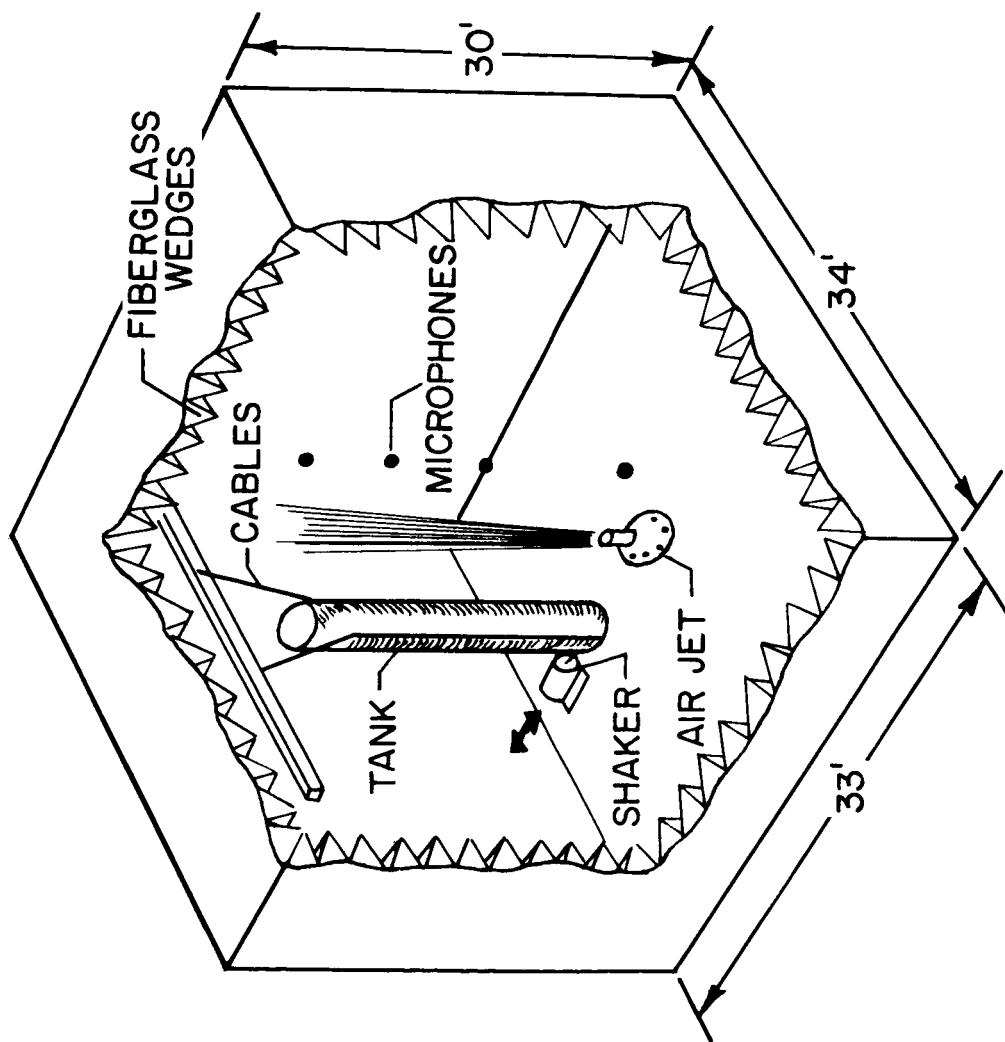
Figure 11.- Acoustic test chamber for missile fuel tank response studies.

The capability exists for the tank to be mechanically excited by an electric vibrator and then acoustically excited by the random noise of an air jet. Accelerometers were installed along the length of the tank, and a microphone array was used for noise measurements. This setup of figure 11 permits a study of the tank response to both mechanical and acoustical excitation and, in addition, provides a measure of its acoustic radiation under controlled conditions.

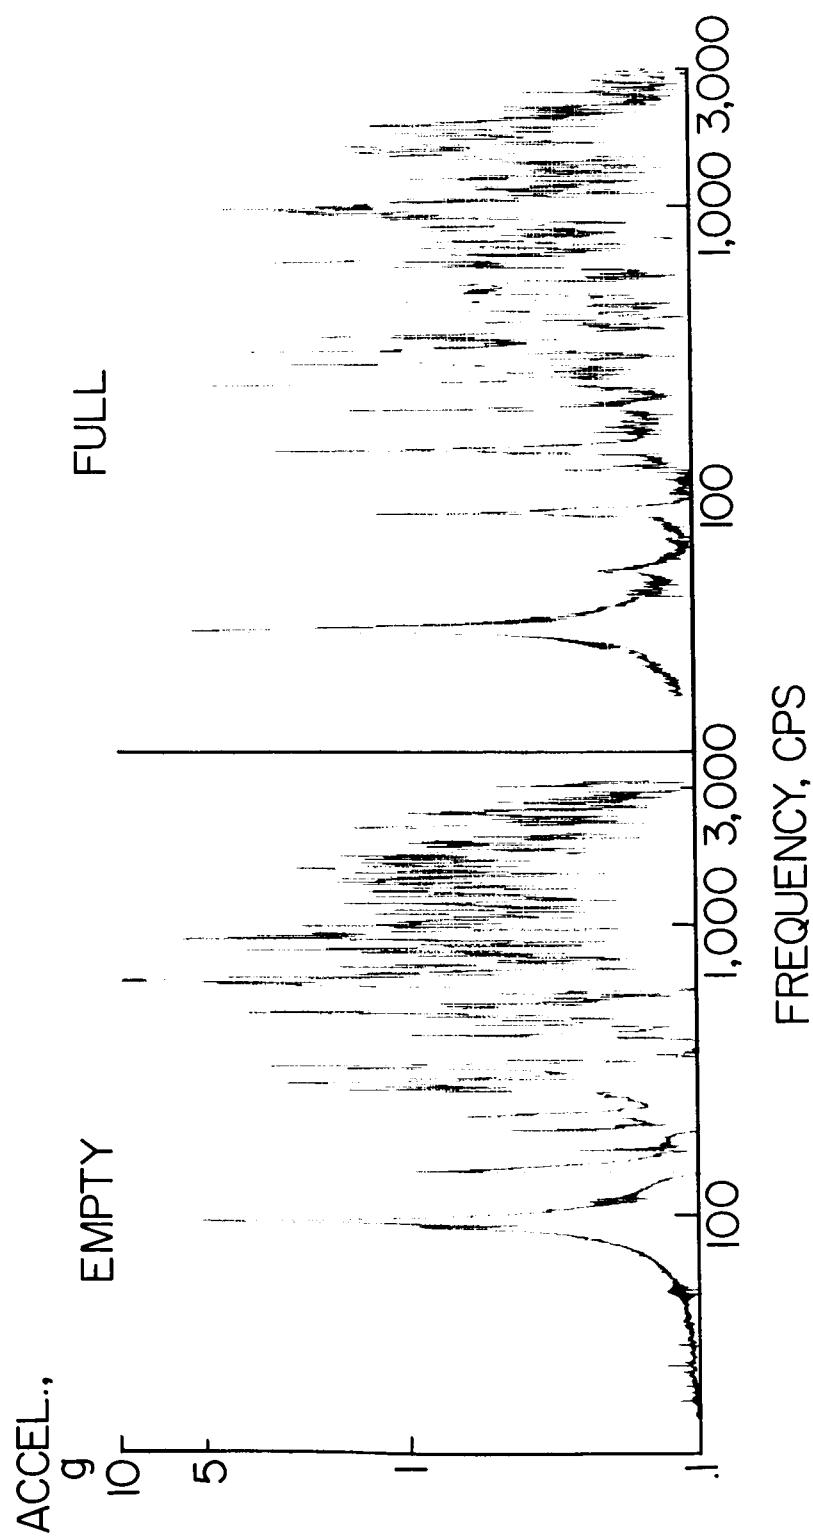
Figure 12.- Response of 1/5-scale Saturn with and without fuel.

As an indication of the vibration response of structures of this type, two spectra obtained by William M. Thompson, Jr., of LRC are presented in figure 12. Acceleration responses for a location on the tank surface midway between its ends are shown as a function of frequency for both the empty condition and the full-of-fluid condition. For each condition the sinusoidal driving force of 1 pound was applied at one end and was varied slowly throughout the test range. The roll-off at high frequency is due to limitation of instrumentation. It can be seen that the tank exhibits a very complex vibration response, and a large number of vibration modes can be identified. For this particular model, the dominant modes happened to occur in the frequency range of conversational speech, and a voice input to the mechanical shaker was quite faithfully reproduced into audible signals by the tank. As a matter of information, the vibration response of the tank was not markedly different when filled with fluid, as can be seen in the right-hand graph. The peak acceleration amplitudes are approximately equal to those of the empty tank, and the most readily observed difference in tank response is the appearance of some clearly defined, low-frequency modes for the case where the tank is filled with fluid. Further experiments are planned in order to evaluate the structural and radiation damping and the manner in which the tank responds to a broad-band acoustic input.

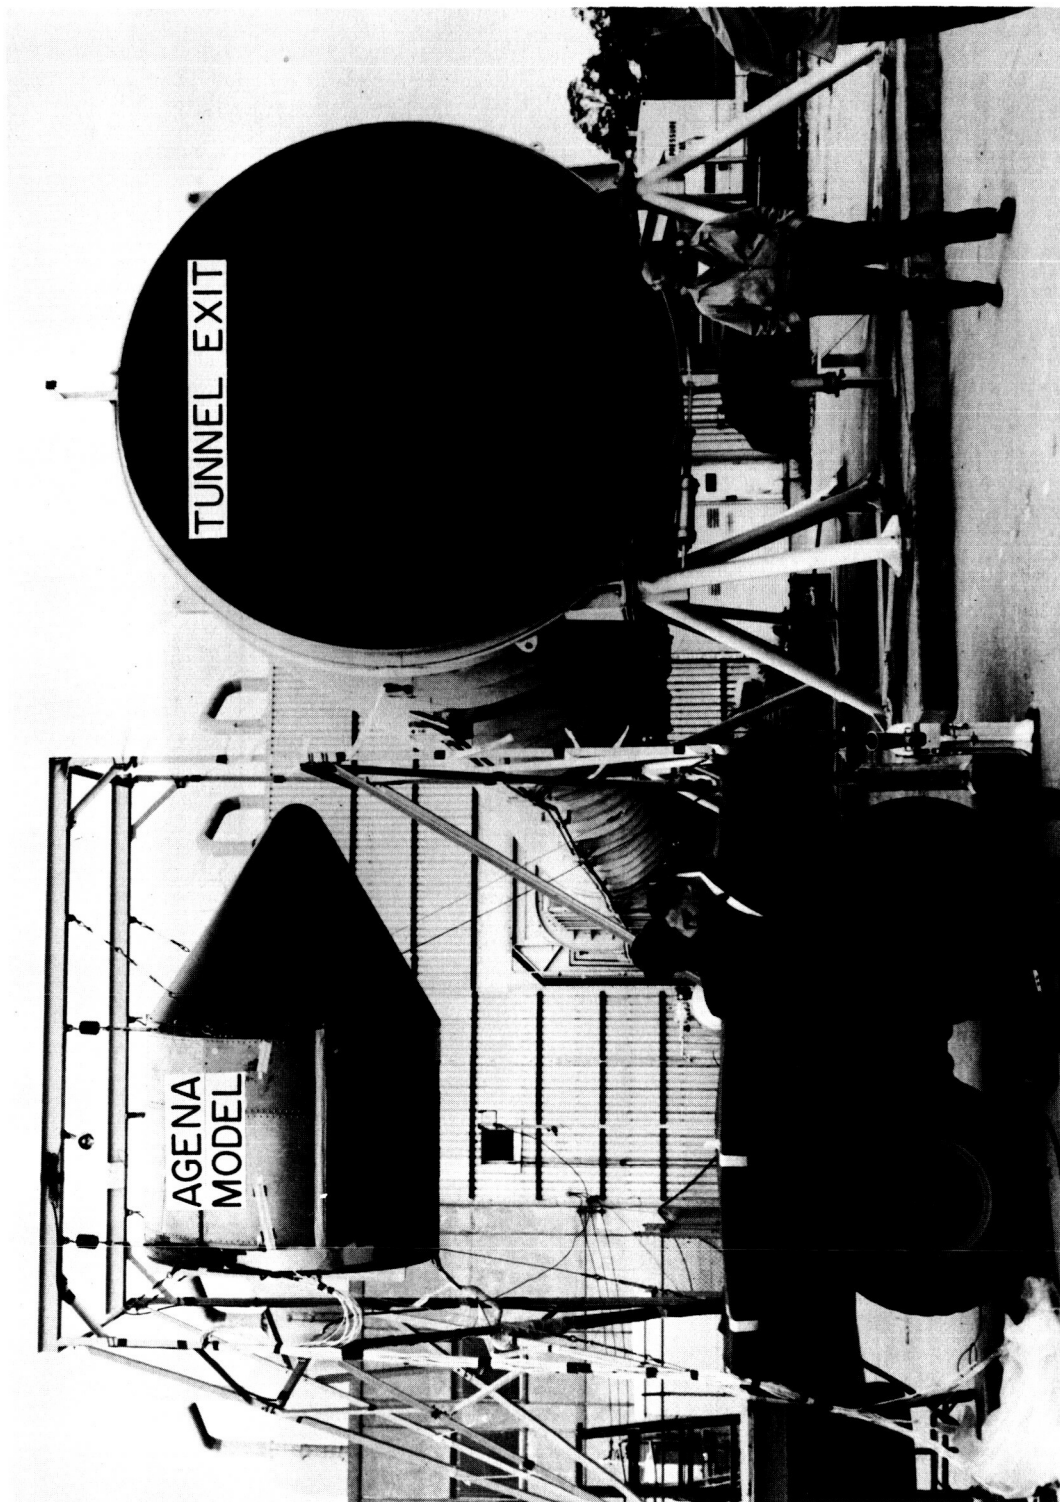
Figure 13.- Agena forward equipment rack in acoustic testing position in the noise field of the Langley 9- by 6-Foot Thermal Structures Tunnel.

Acoustic environmental tests of an Agena instrument package have recently been made in the noise field of the Langley 9- by 6-Foot Thermal Structures Tunnel. The tests were made at the request of the Air Force and in association with Lockheed Aircraft of Sunnyvale, California. Figure 13 shows a photograph

of the Agena forward equipment rack in testing position at the tunnel. The view is looking toward a 12-foot-diameter diffuser exit of the tunnel. The Agena model is cradled in a shock-mounting suspension onboard a trailer. In this position, the test specimen is located at the center-line elevation of the tunnel exhaust and only a few feet from the exhaust stream boundary. The Agena package was about 5 feet in diameter and about 5 feet long. The aft end was sealed off with a nonflight structure, and the fore end was equipped with a dummy nose cone. The package was of skin stringer construction with skin surfaces being beryllium. Tests were made in a random noise environment, and accelerometer measurements were taken on structural members throughout the model.

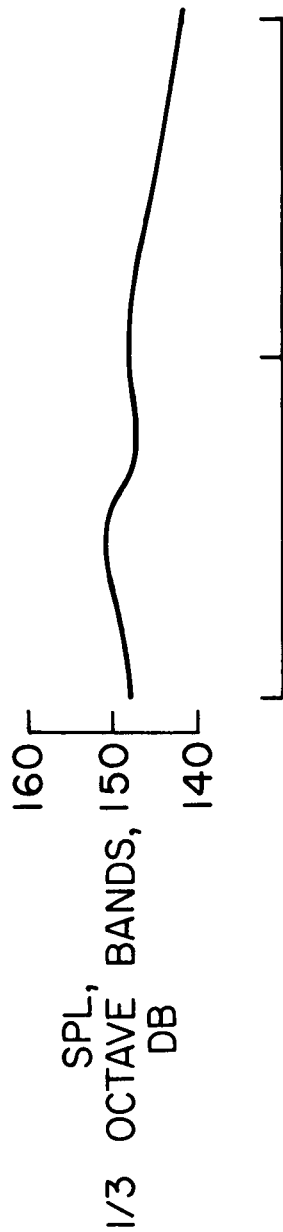
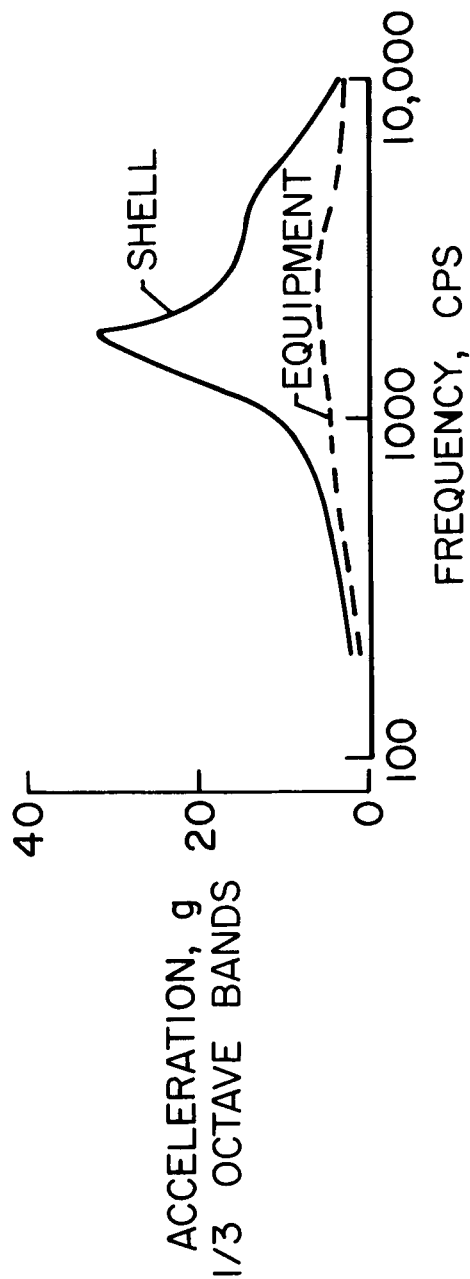
Figure 14.- Acceleration responses measured during acoustic tests of the Agena forward equipment rack.

Representative results from these studies are included in figure 14. At the top of the figure is shown the acoustic input in one-third octave levels. At the bottom of the figure are shown the resulting accelerations in one-third octave bands measured at two locations in the model. The acoustic input is noted to have a flat spectrum within about 5 dB from 100 cps to 10,000 cps. The acceleration responses, on the other hand, are noted to increase with increasing frequency up to about 2,000 cps which is approaching the useful upper limit of frequency of the accelerometer equipment. The accelerations of the shell structure were noted to peak at about 30g, whereas the peak accelerations measured on the more massive gyro guidance equipment are markedly lower, as would be expected, and in this case did not exceed about 6g. Such experiments as these are frequently required for complex structures designed for specific acceleration tolerances since at present there are no acceptable analytical means for accomplishing this task. It is hoped that basic information such as is presented here will be useful in the formulation of acceptable prediction schemes for future vehicles.
